WL-TR-91-4032
DOT/FAA/CT-91/23
VOL II, Part 2

COMPOSITE FAILURE ANALYSIS HANDBOOK
VOL II - TECHNICAL HANDBOOK
PART 2 - ATLAS OF FRACTOGRAPHS

R.J. Kar
Northrop Corporation
One Northrop Avenue
Hawthorne, California 90250-3277

February 1992

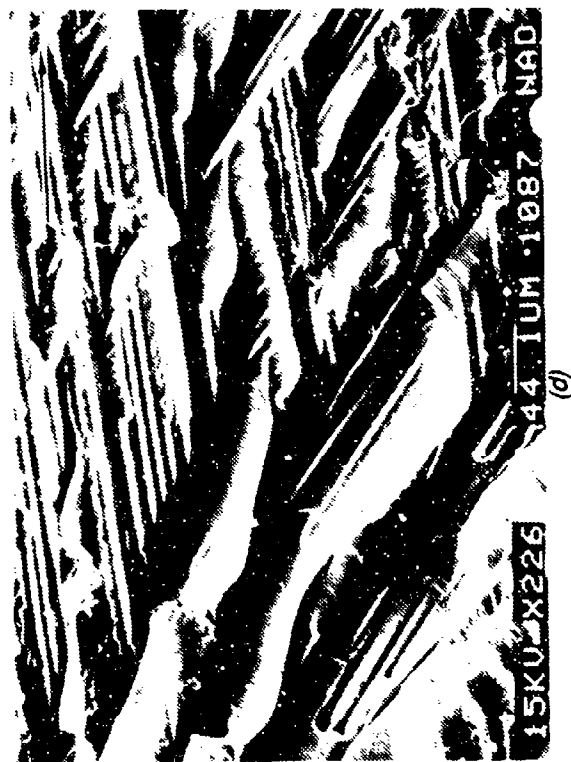
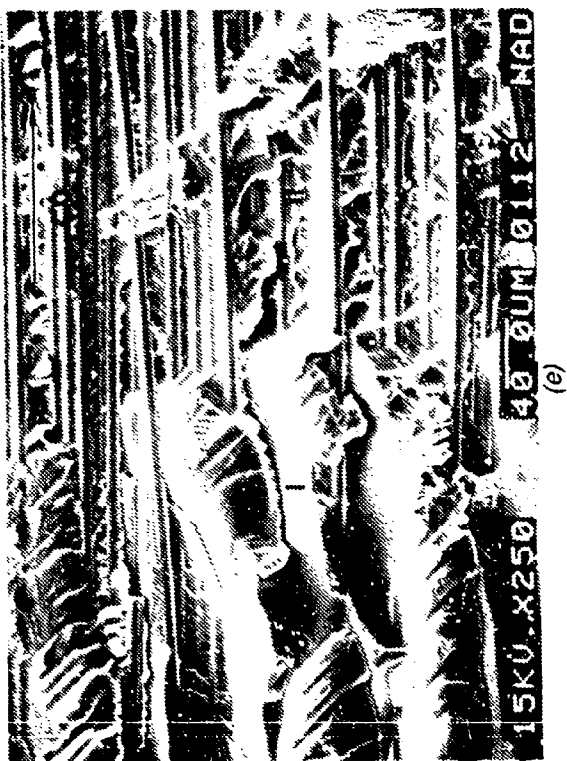
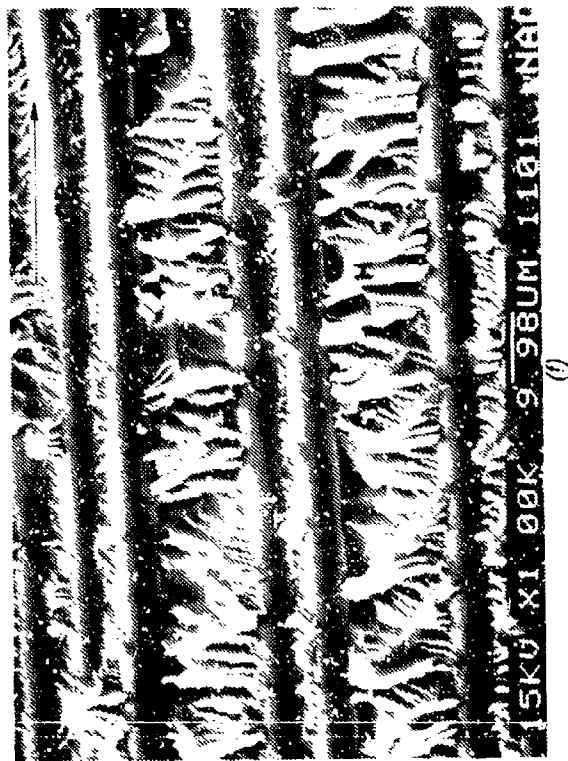
Figure 2-89. (Continued)
 (d) River Patterns in Resin Between 0 and 45 Degree Piles
 (e) Mode I/Mode II Interface
 (f) Hackles (H) in Region II
 CD = Crack propagation direction

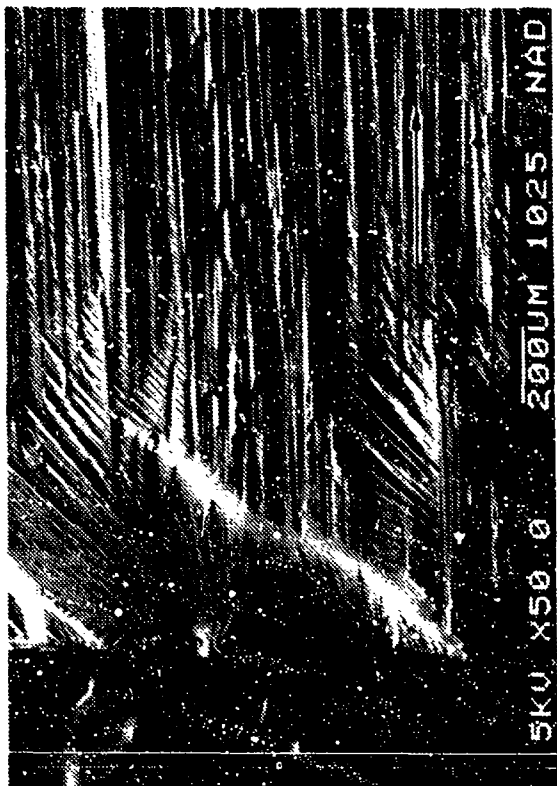
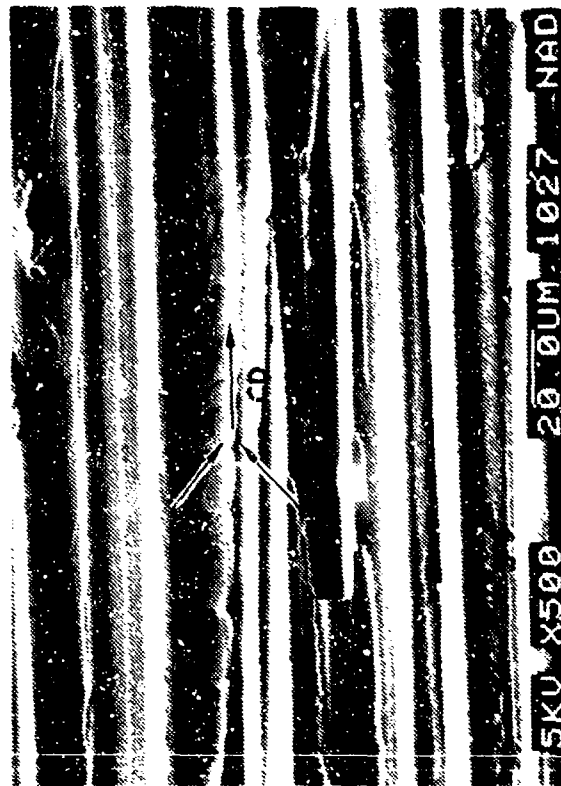
Figure 2-90. Optical and SEM Photographs of Mode II ENF Shear Interlaminar Fracture in Overcured Gr/Ep - [0]_{24T}
 (a) Macro photograph of Fracture
 (b) Initiation Site in Region I
 (c) Mapping of CD With River Patterns (Arrows)

CD - Crack propagation direction

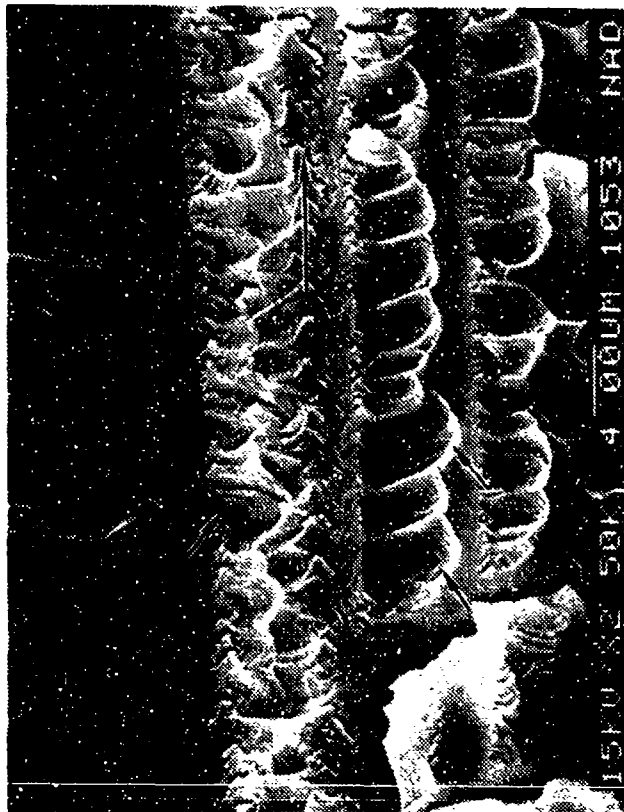
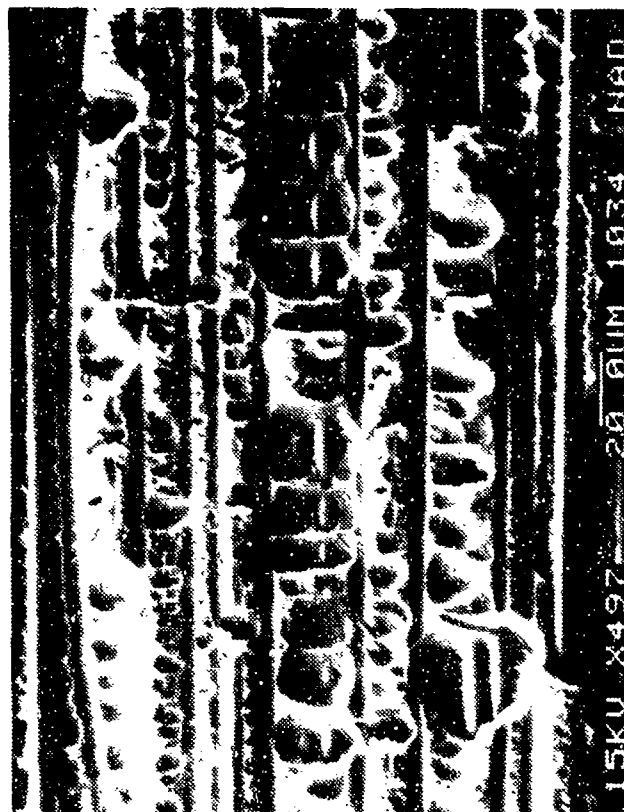
Figure 2-90. (Continued)
 (d) Hackles (H) and Scallops (S) in Region II
 (e) Microflow Lines in Scallops in Region II

CD = Crack propagation direction

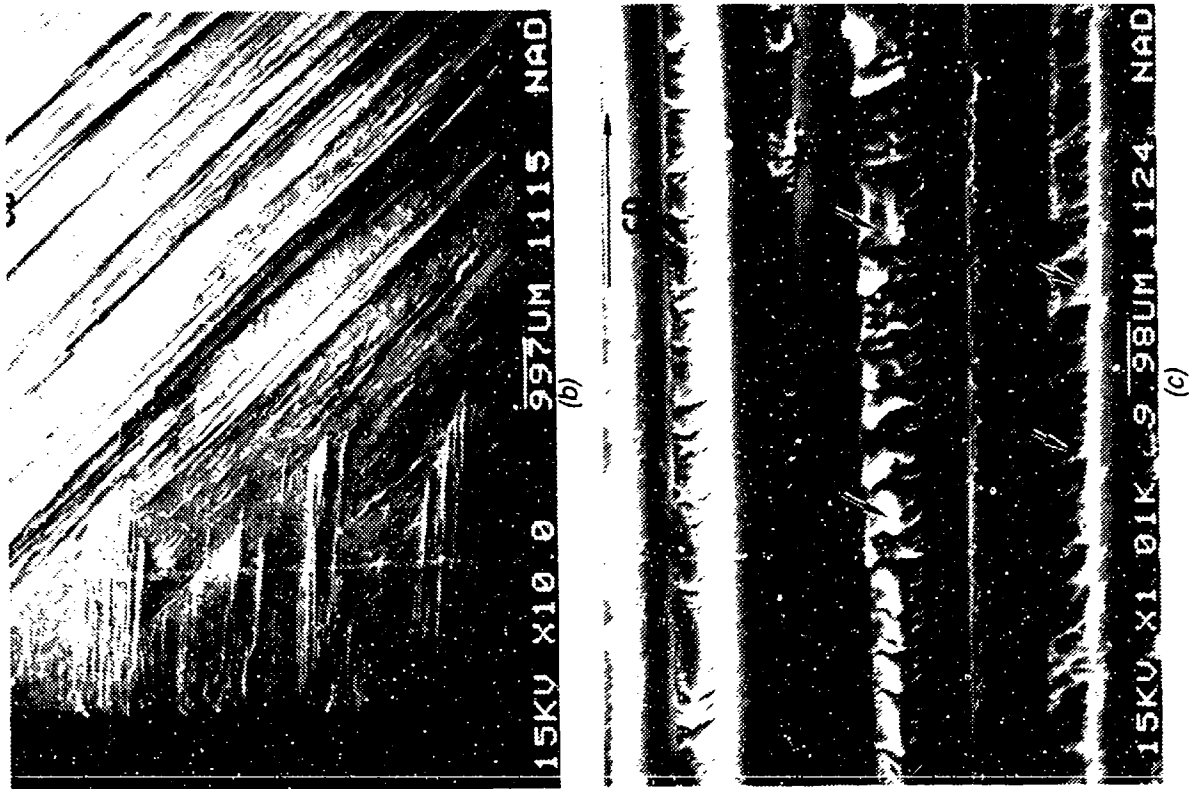
Figure 2-91. Optical and SEM Photographs of Mode II ENF Shear Interlaminar Fracture in Overcured Gr/Ep - [+45/0/-45]_s
 (a) Macro photograph Showing Regions I, II, and III (Precrack, Crack-Growth, Laboratory Overload)
 (b) Initiation in Resin Between 0 and 45 Degree Plies (c) Hackles (H) and Scallop (S) in Region II
 CD = Crack-propagation direction

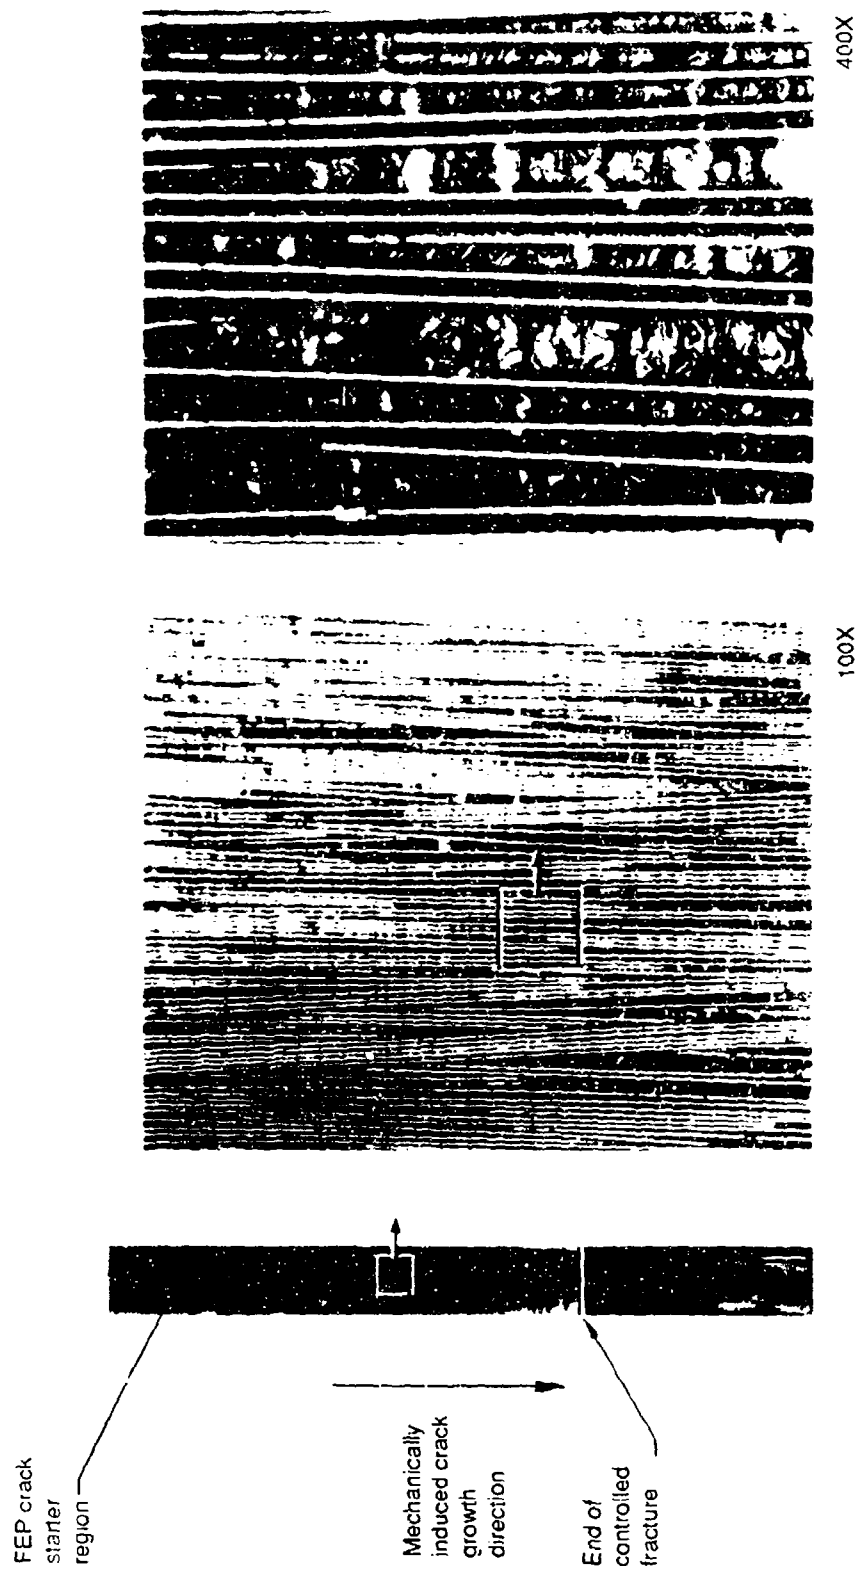
Figure 2-92. Optical Photomicrographs of Interlaminar Mode II Shear, 0/90 Fracture of Low Resin Content Specimen

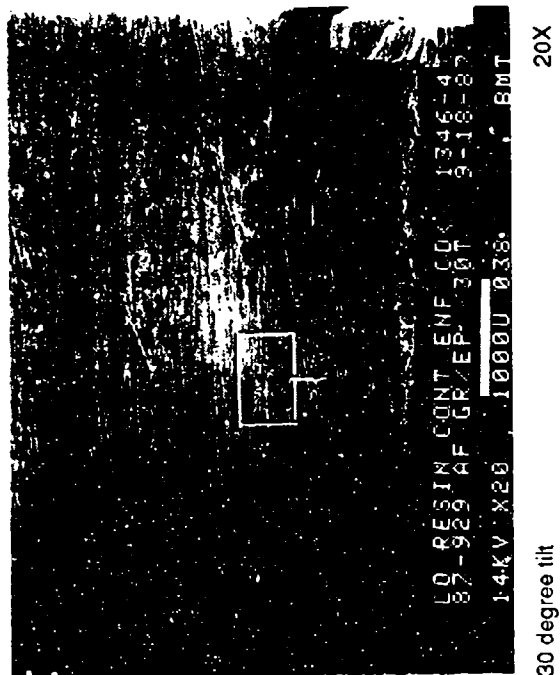
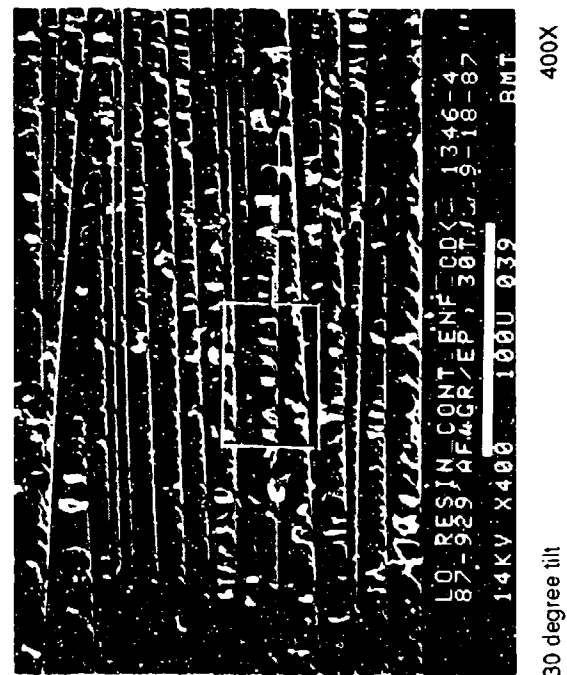
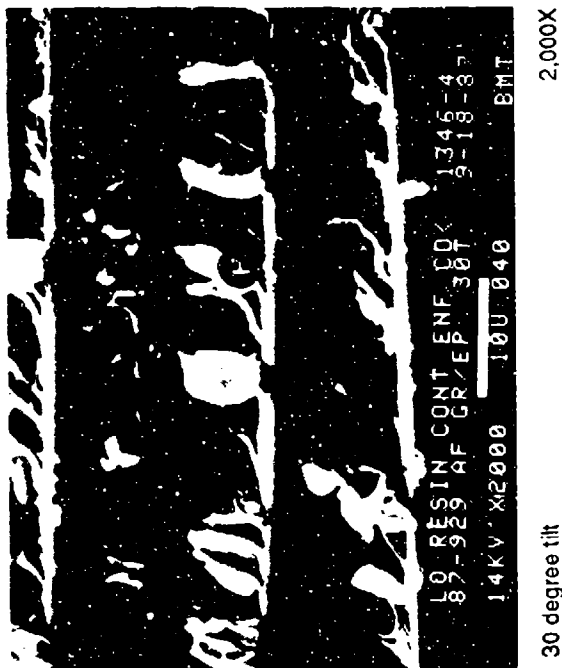
Legend:
 F fiber/matrix separation
 H hackles
 R rivermarks
 Mechanically induced crack direction
 →

Figure 2-93. SEM Fractographs of Interlaminar Mode II Shear, 0/90 Fracture of Low Resin Content Specimen

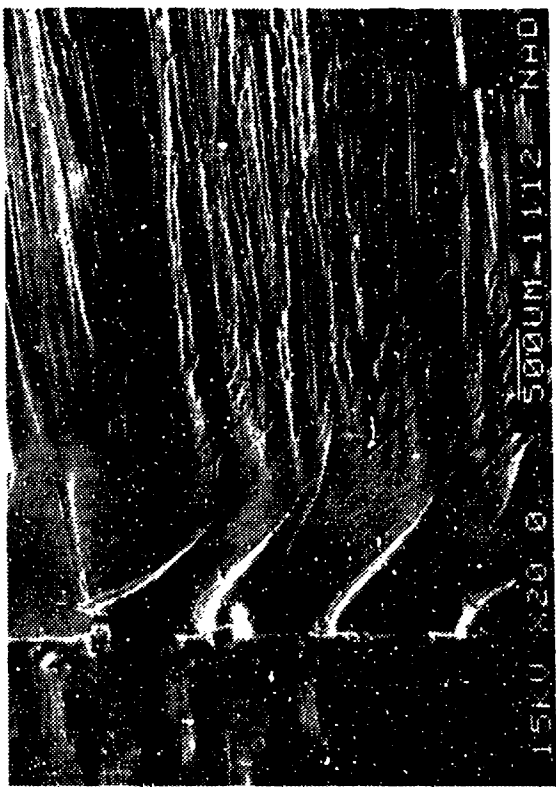
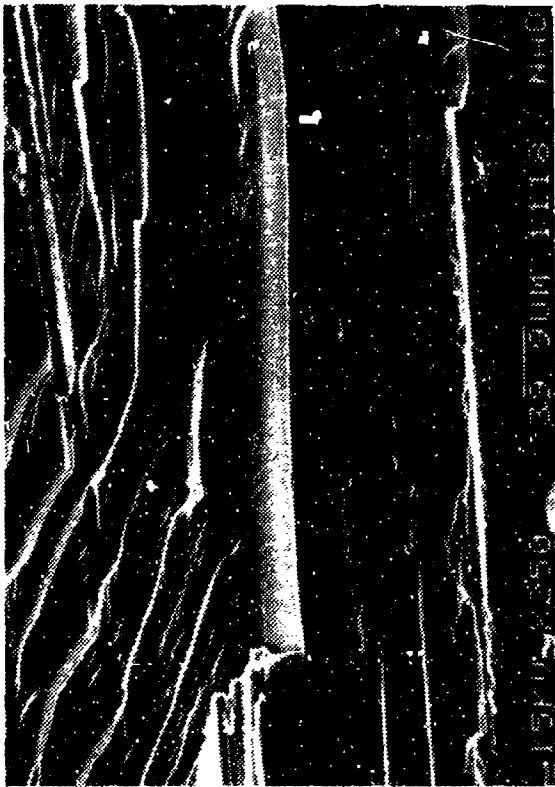
Figure 2-94. Optical and SEM Photographs of Mode II ENF Shear Interlaminar Fracture in High Resin Content Gr/Ep - [0]_{24T}
 (a) Macro photograph Showing Region I, II, and III
 (b) Local Initiation in Region I
 (c) River Patterns Indicate CD

CD = Crack propagation direction

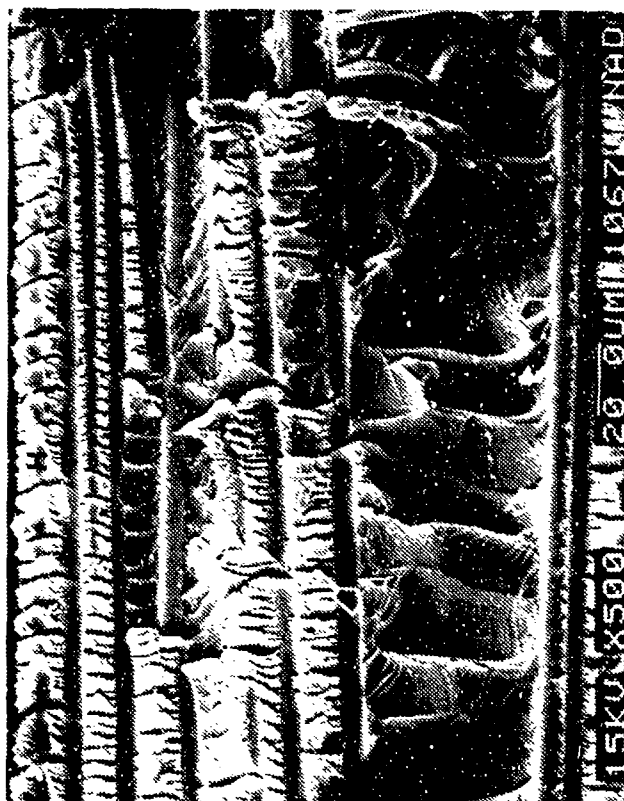
(d)

Figure 2-94. (Continued)
 (d), (e) Mode II Shear Fracture in Region II
 Note hackles (H), scallops (S), resin micro-flow
 (Arrows) and S-shaped cracks

CD = Crack-propagation direction

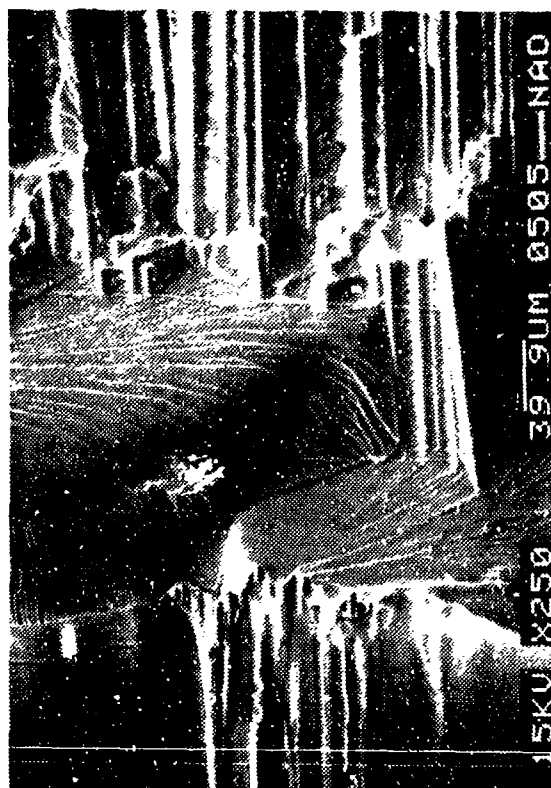
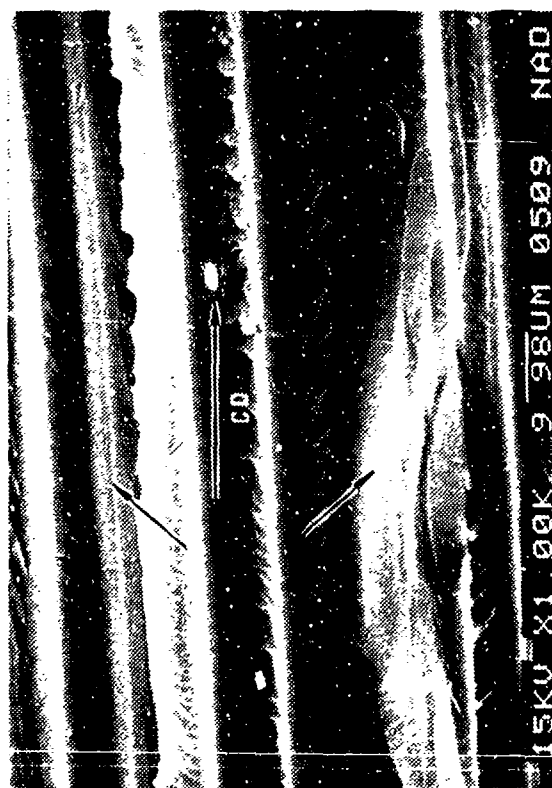
Figure 2-95. Optical and SEM Photographs of Mode II ENF Interlaminar Shear Fracture in High Resin Content Gr/Ep - [0/90]_{6s}
 (a) Macrograph Showing Regions I, II, and III (Precrack, Mode II Shear, Laboratory Overlay)
 (b) Initiation Occurring in Mode I Resin-Rich Areas
 (c) River Patterns (Arrows) in Mode I Tension Fracture Area That Can Be Used to Map CD

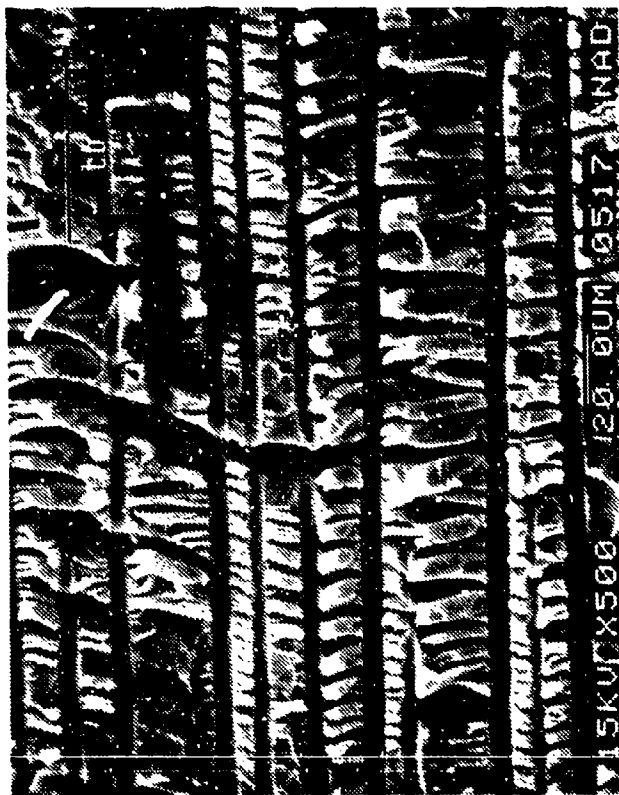
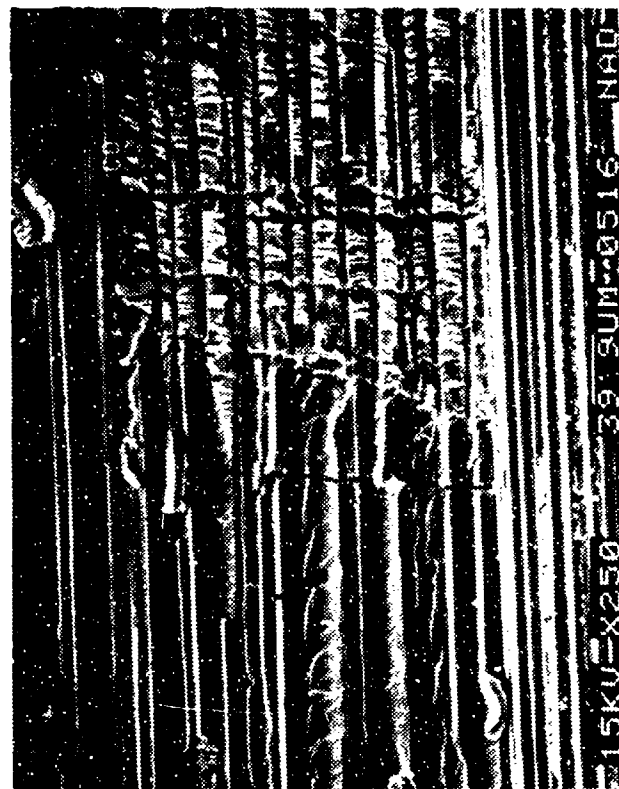
Figure 2-95. (Continued)
 (d) Mode I/Mode II Interface
 (e) Hackles (H) and Scallops (S) in Mode II Fracture
 CD = Crack-propagation direction

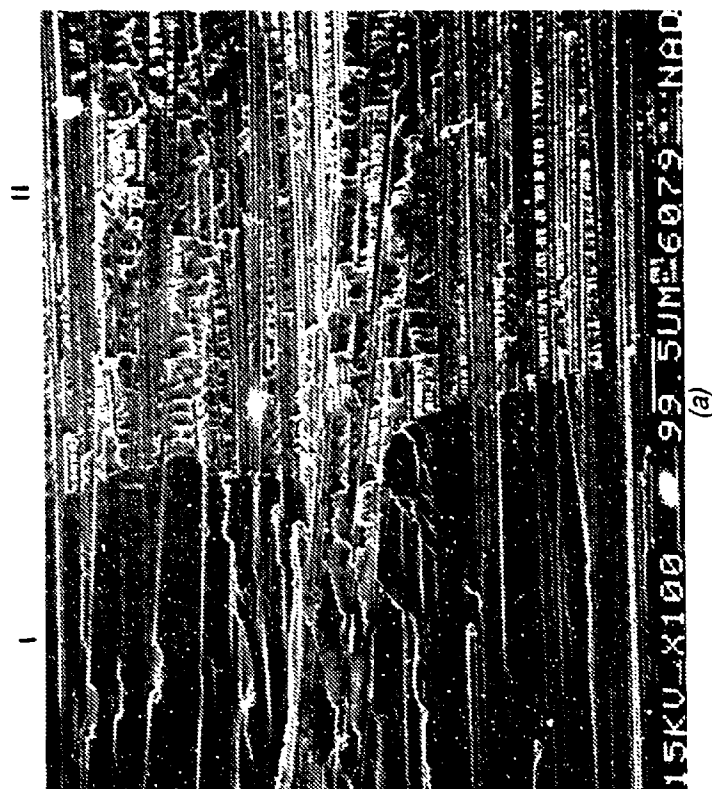
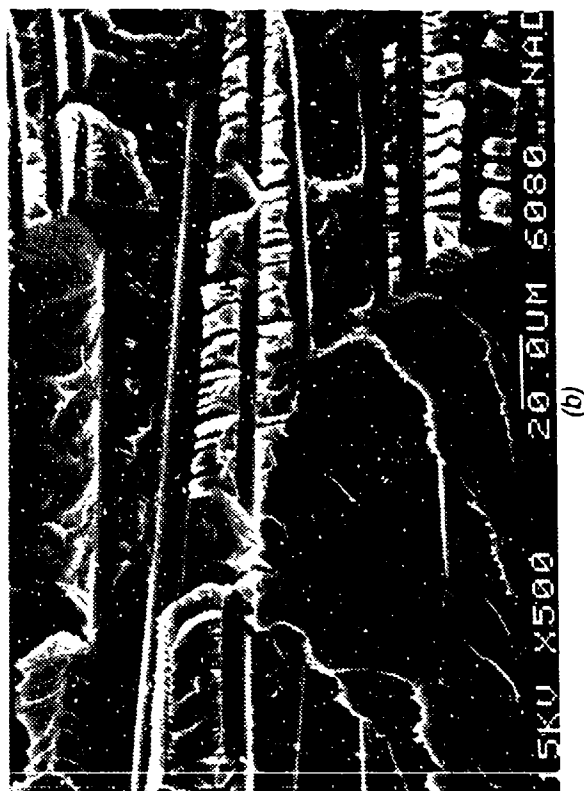
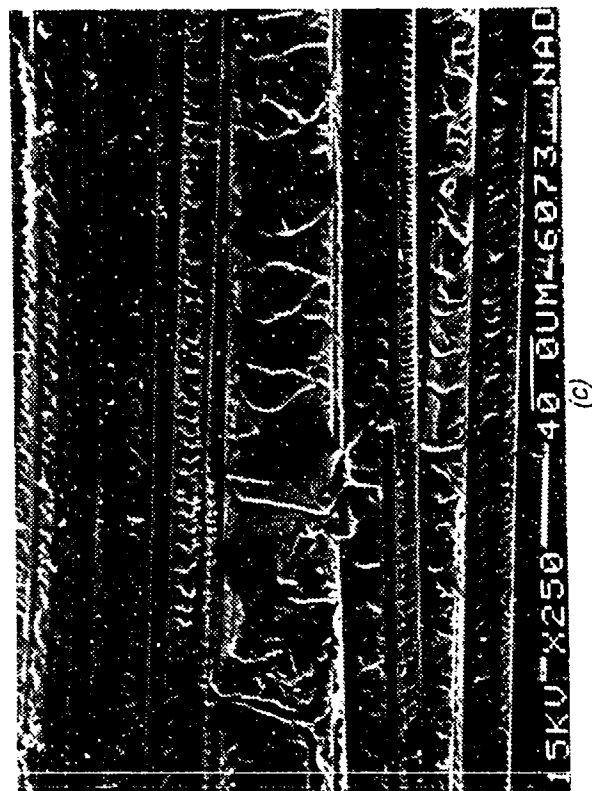
Figure 2-96. SEM Photographs of Mode II ENF Interlaminar Shear Fracture in High Resin Content Gr/Ep, Conditioned 180 F/Dry After Test

(a) Precrack to Crack-Growth Transition Region in [0] 24T Coupon
 I = Precrack, II = Crack-growth

(b) Details of Fracture in (a)
 R = River patterns, H = Hackles, S = Scallops

(c) Hackles (H) in Crack-Growth Region of [0/90]_{es} Coupon

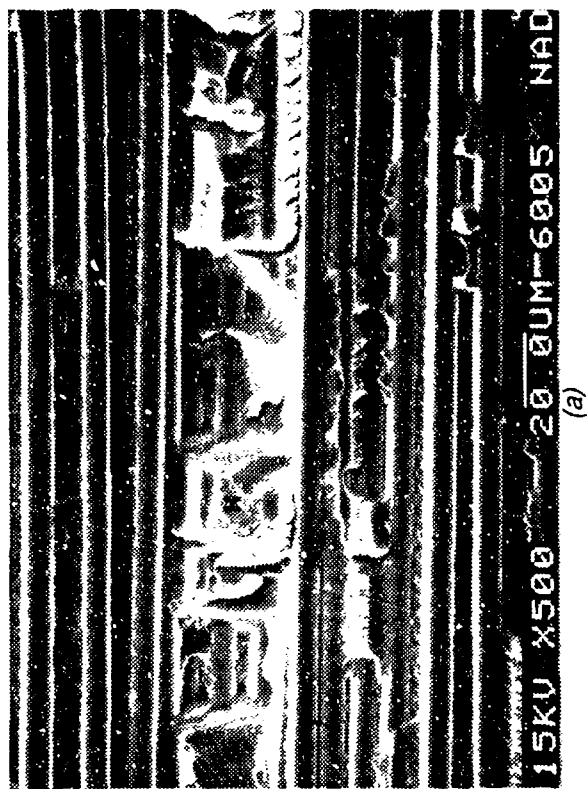
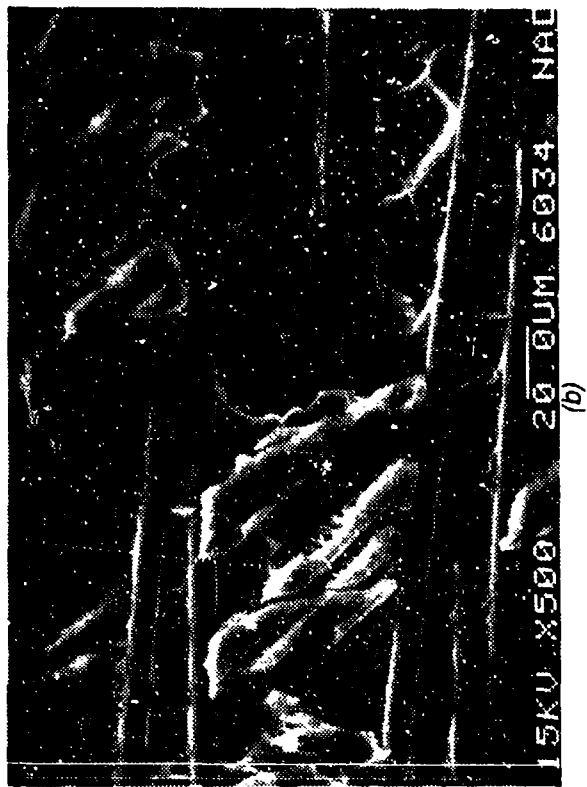
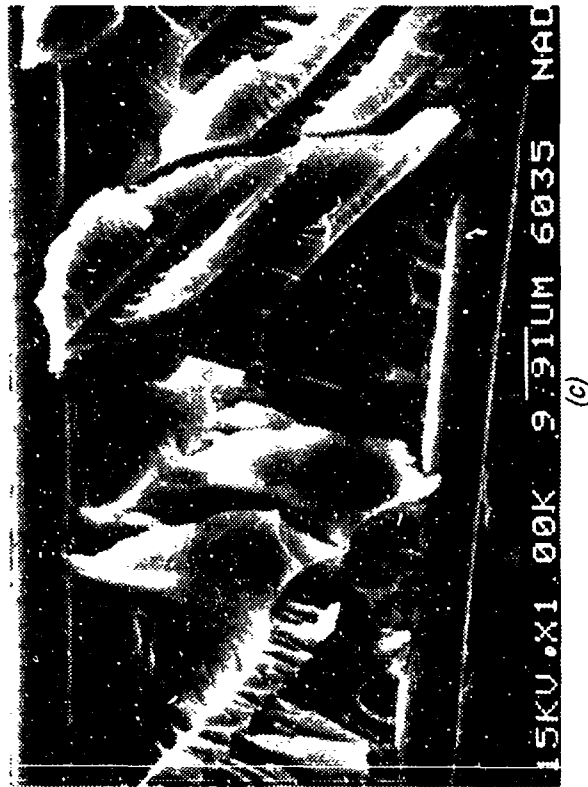
Figure 2-97. SEM Photographs of Mode II ENF Interlaminar Shear Fracture in Overcured Gr/Ep, Conditioned 180 F/Wet After Test

(a), (b) Crack-Growth Regions in $[0]_{24T}$ and $[\pm 45/0/\pm 45]_{4S}$ Coupons, Respectively
Note bare fibers and hackles (H)

(c) Detail of Area Shown in (b)
Note random river patterns on hackles

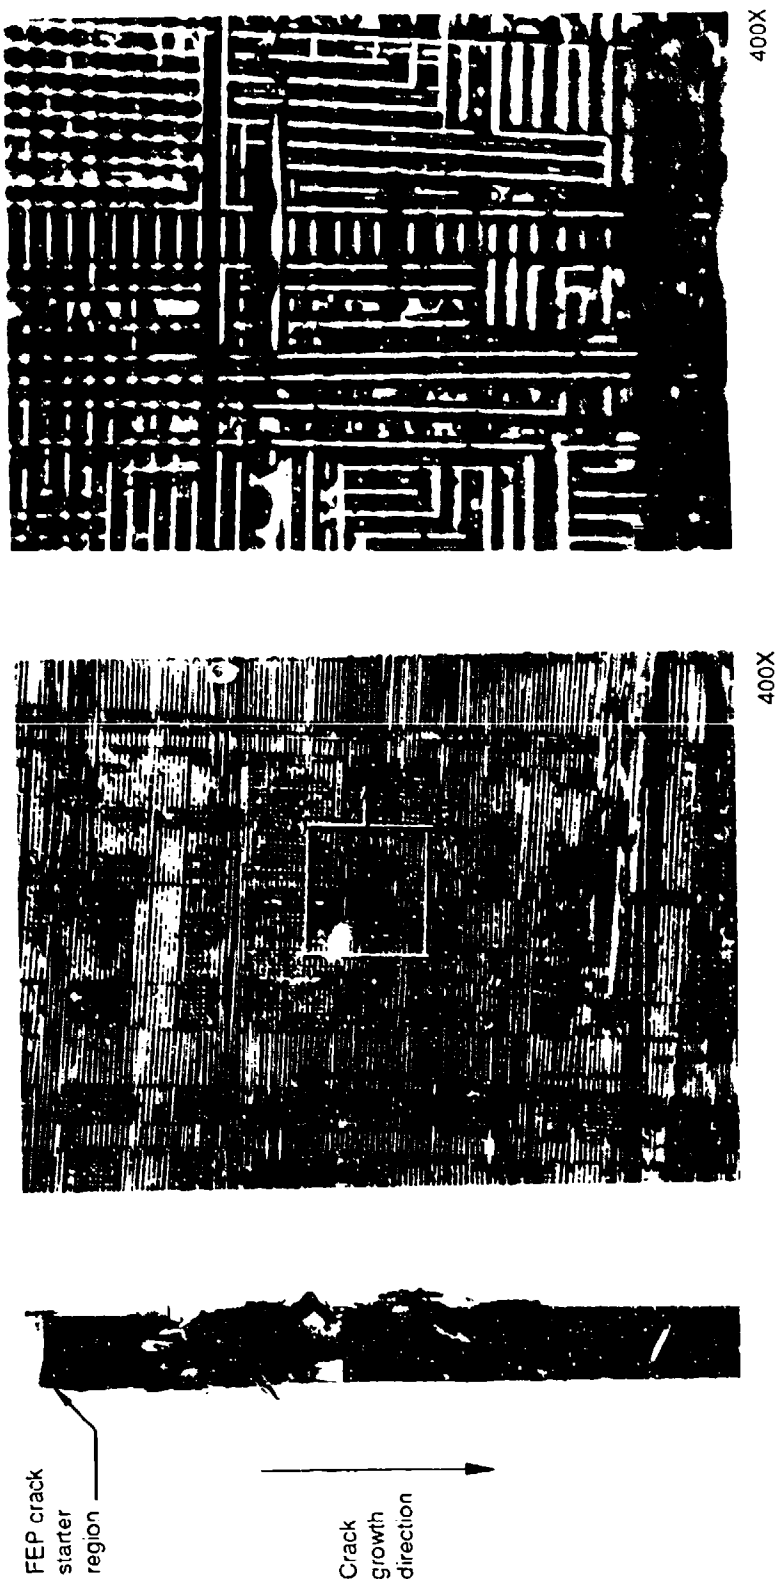
Figure 2-98. Optical Photomicrographs of Interlaminar Mode II Shear, 0.90 Fracture, 2000 F Exposure for 5 Minutes After Test

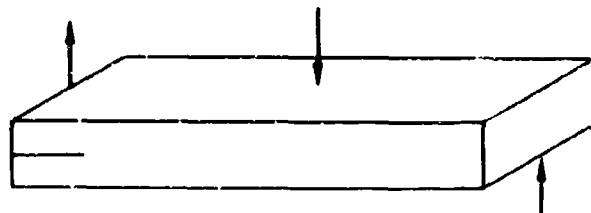
The mixed mode flexural (MMF) test geometry, shown in Figure 2-100, produces 57 percent Mode I tension and 43 percent Mode II shear at the crack tip. The macroscopic fracture surface characteristics are as follows:

Figure 2-100. Mixed Mode Flexural Test Type

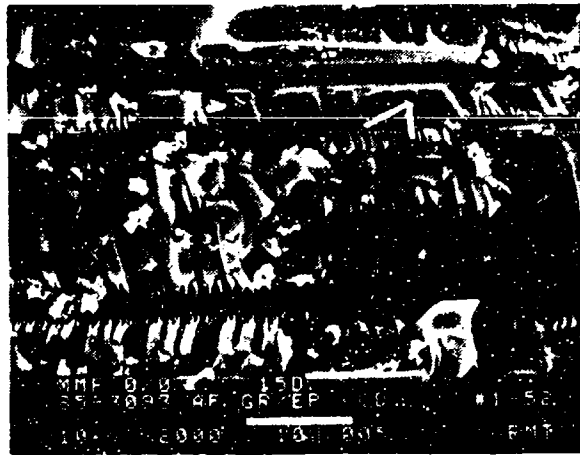
Fracture type	Interlaminar mixed mode (I and II)
Ply layup	[0] ₂₄
Test type	Mixed mode flexure (MMF)
• Test conditions	21°C, dry
• Fracture between	0/0 plies
Material	Hercules 3501-6/177°C cure AS4 fibers

Figure 2-101. SEM Photograph of Interlaminar Mode I and Mode II, 0/0 Fracture, 70 F/Dry

1. Macroscopically flat surface
2. Microscopically rough resin fracture with a predominance of hackles and scallops
3. Small localized regions of flat resin fracture exhibiting only river marks and resin microflow.

SEM examination of mixed-mode interlaminar failures indicates that these are characterized by mixtures of hackles or scallops and river patterns that are generally interspersed between the hackles. The river patterns can be used to map local fracture origins and direction as for pure Mode I tension. Processing variations (overcure or undercure), material form (filament winding versus tape), or post-processing variables (impact-damage) do not significantly alter the fracture characteristics.

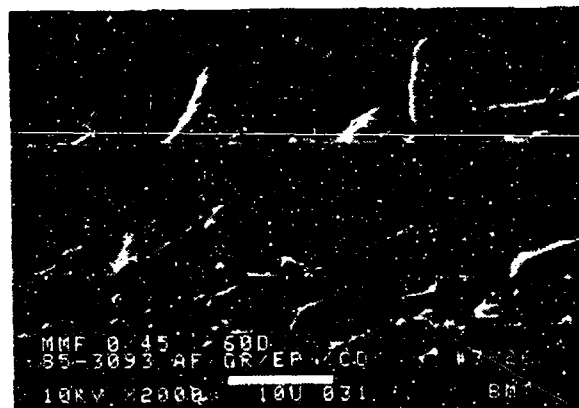
Fracture type	Interlaminar mixed mode (I and II)
Ply layup	[0, 45] _{12S}
Test type	Mixed-mode flexure (MMF)
• Test conditions	21°C, dry
• Fracture between	0/45 plies
Material	Hercules 3501-6/177°C cure AS4 fibers

Figure 2-103. SEM Photographs of Interlaminar Mode I and Mode II, 0/45 Fracture, 70 F/Dry

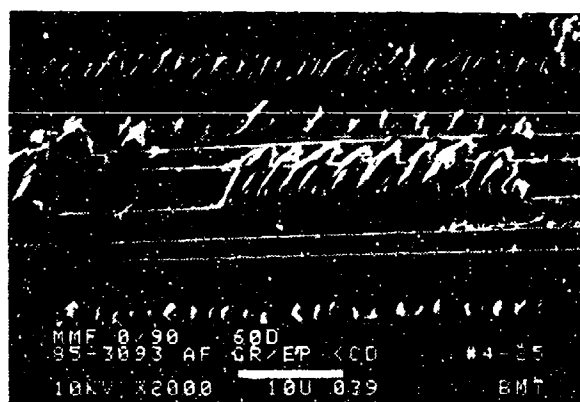
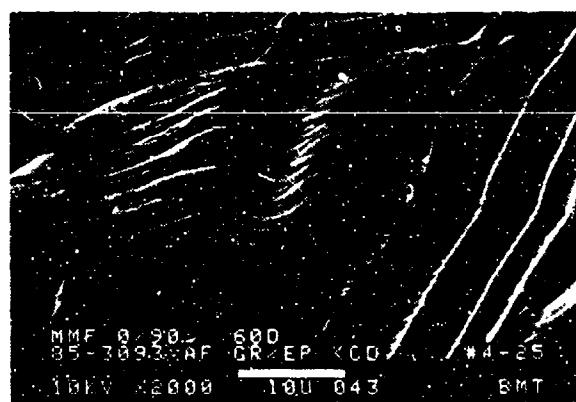
Fracture type	Interlaminar mixed mode (I and II)
Ply layup	[0, 90] ₁₂ S
Test type	Mixed-mode flexure (MMF)
• Test conditions	21°C, dry
• Fracture between	0/90 plies
Material	Hercules 3501-6/177°C cure AS4 fibers

Figure 2-104. SEM Photographs of Interlaminar Mode I and Mode II, 0/90 Fracture, 70 F/Dry

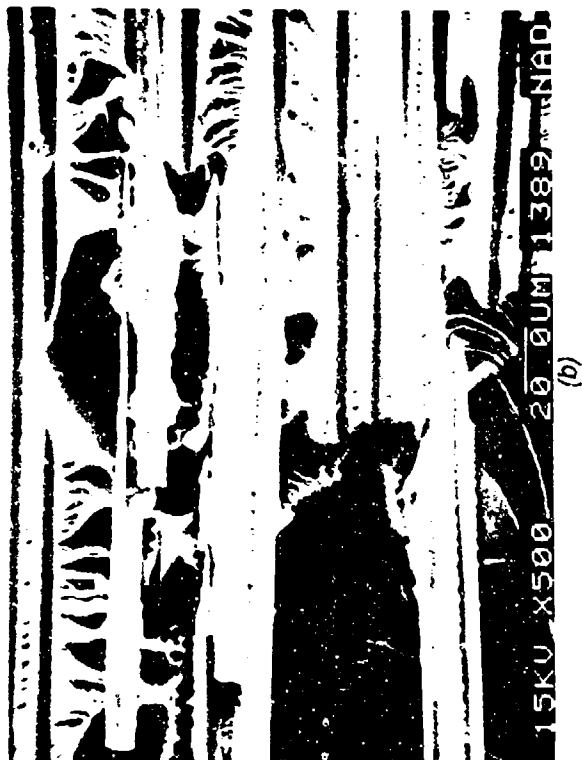
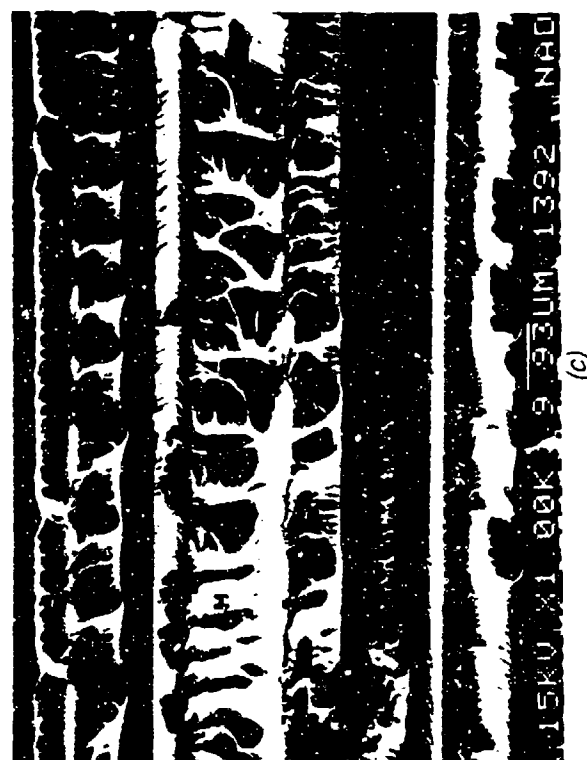
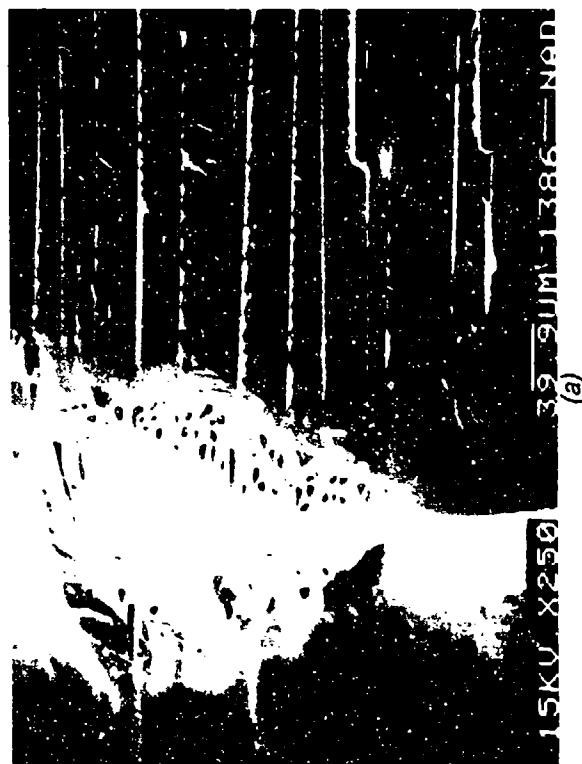
Figure 2-105. SEM Photographs of Mode I and Mode II MMF Interlaminar Fracture in Filament Wound Gr/Ep - [0]_{24T}
 (a) River Patterns (R) at Initiation Site (Precrack Region)
 (b) Precrack to Crack-Growth Transition Region (Mode I Tension to Mixed Mode I Tension and Mode II Shear)
 (c) Hackles (H) and River Patterns (R) in Crack-Growth Region

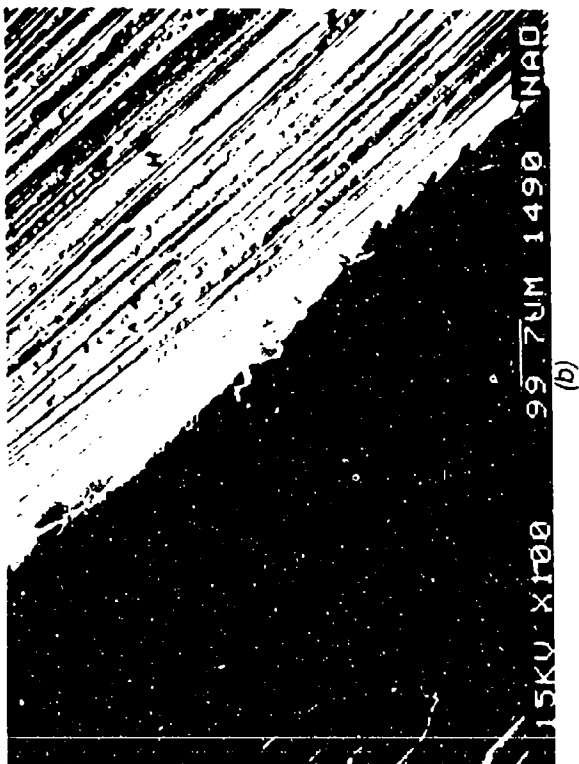
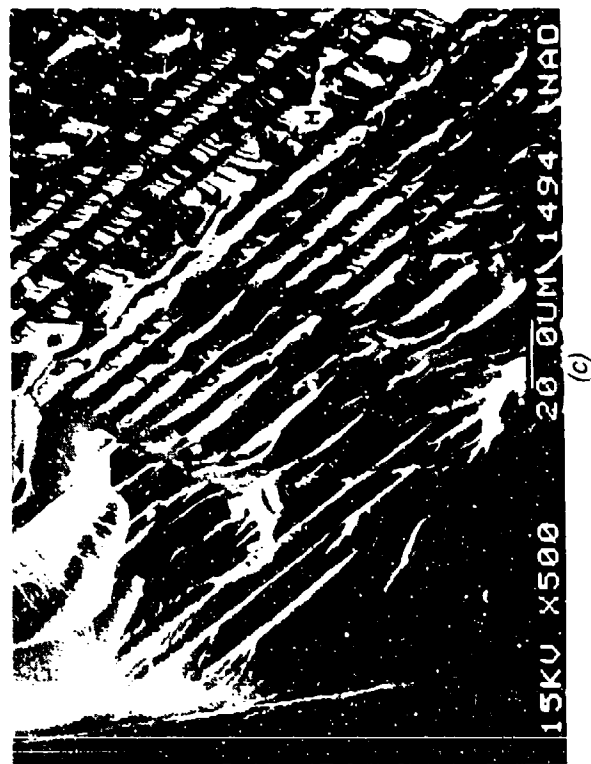
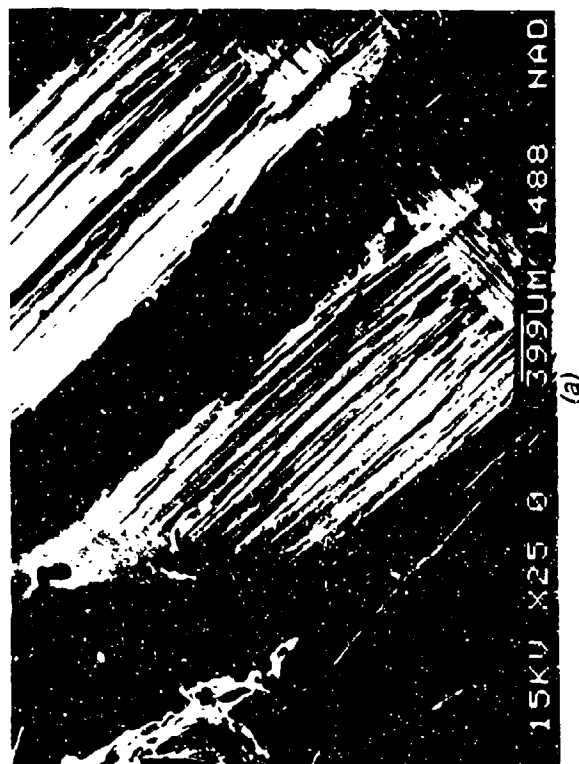
Figure 2-107. SEM Photographs of Mode I and Mode II MMF Interlaminar Fracture in 3-D Weave Gr/Ep - [+45/0/-45] ₄₅

(a) Initiation in Precrack Region of Coupon

(c) Hackles (H) and River Patterns (R) in Crack-Growth Region

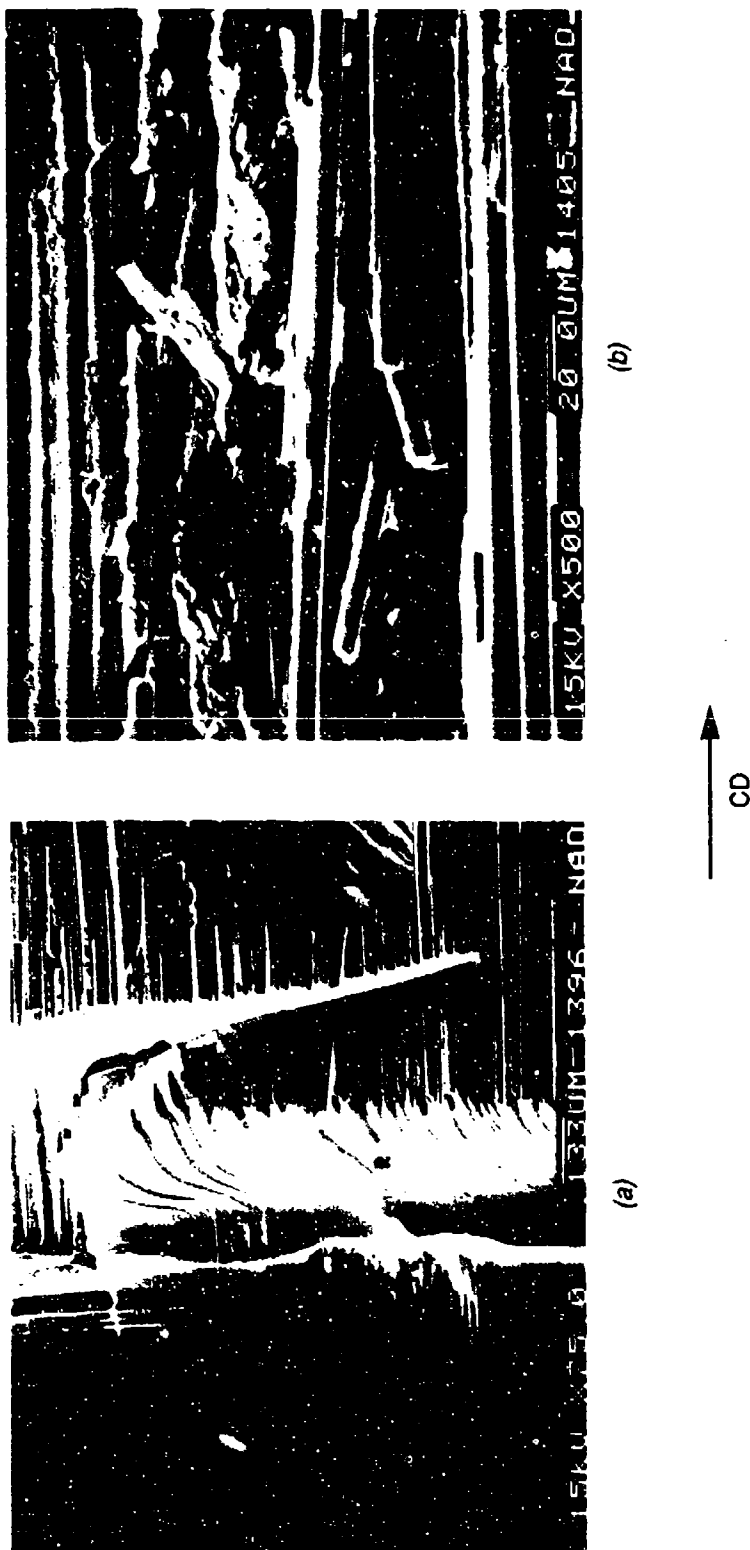
Figure 2-108. SEM Photographs of Mode I and Mode II MMF Interlaminar Fracture in Impact Damaged Gr/Ep - [0] _{24T}

(a) River Patterns in Precrack Initiation Region

(b) Impact Damage Area in Crack-Growth Region

Note broken fibers and crushed resin

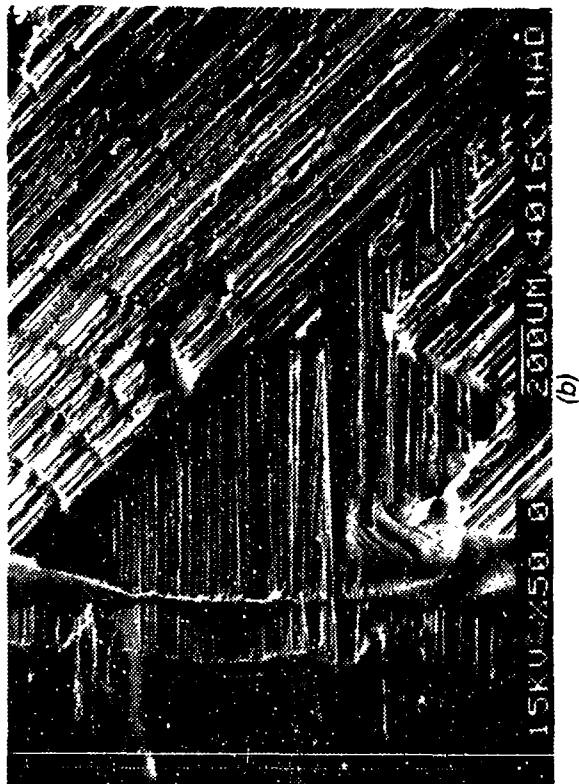
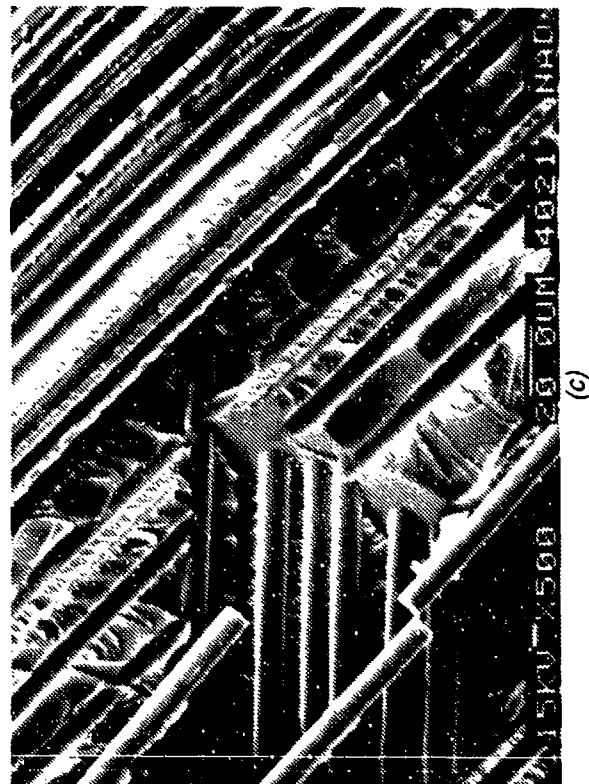
Figure 2-109. Optical and SEM Photographs of Mode I and Mode II MMF Impact Damaged Grl/Ep - [+45/0/-45]_{4S}
 (a) Macrophotograph Showing Regions I, II, III and IV (Precrack, Crack Growth Under Mode I Tension and Mode II Shear, Laboratory Overload, Impact Damage)
 (b) Initiation in Resin-Rich Areas
 (c) River Patterns in the Mode I Fracture Region

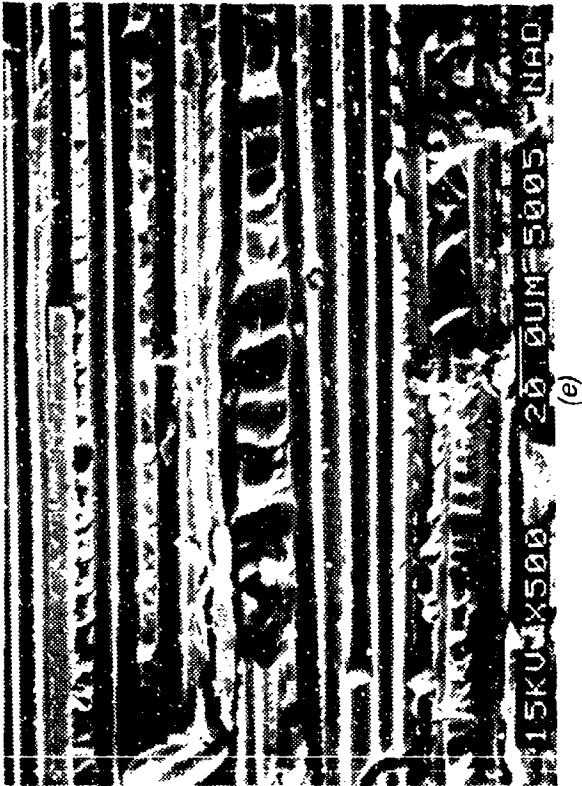
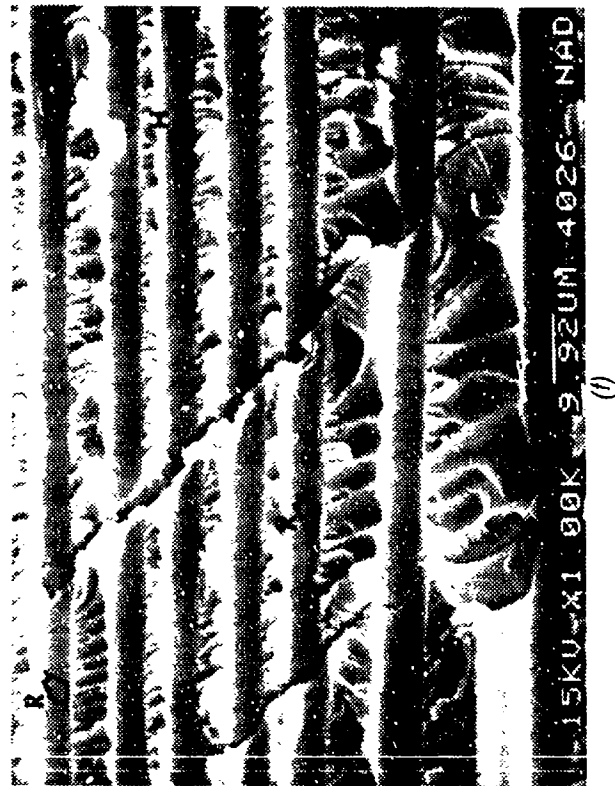
Figure 2-109. (Continued)
 (d) Interface Between the Mixed-Mode Region II and the Impact Region IV
 (e) Crushed Resin and Debris in the Impact Damaged Area
 (f) Mode I Tension and Mode II Shear Fracture Region
 Note the presence of river patterns (R), hackles (H), scallops (S) and localized cracks

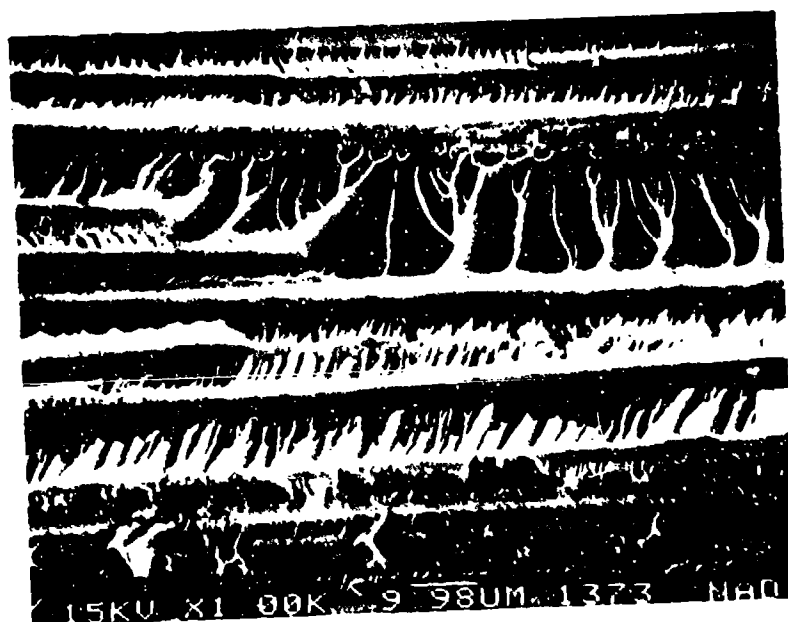
Figure 2-110. SEM Photograph of Mode I and Mode II MMF Interlaminar Fracture in Gr/Ep - [0] _{24T}, Water Immersion Before Test
 Note hackles and river patterns
 CD = Crack-propagation direction
 H = Hackles
 R = River patterns
